State of the Art, Inc.

Thin film MIL-PRF-55342 termination material B (solderable) metal voids

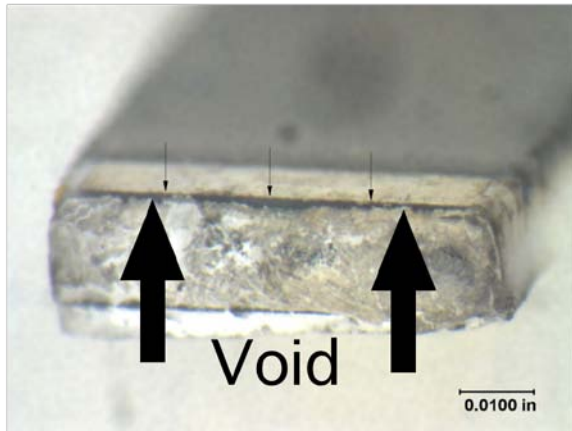
D55342E07B10B0R, 0728J, BA2685

Three customers have reported a total of four thin film B termination material MIL-PRF-55342 devices exhibiting open circuit conditions after reflow solder mounting (Figure 1). All four devices were identified by routine electrical and visual inspection of the mounted devices. The assembly failures were reported on Feb. 5th 2009, August 31st 2010, Oct. 19th 2010, and February 14th 2011. No post assembly failures have been reported, nor have there been any life test failures. (*The thin film devices in question are identified by B termination material and either characteristic symbol E and H or resistance tolerance and multiplier symbols A, B, and C (0.1%).*)

Figure 1. Devices with end face metal voids reported by our customers.

The investigation of the affected lots indicates that the cause of the termination failure is due to voids in the end face metal. The cause of the voids is foreign material contamination preventing the adhesion of the sputtered TiW material to the alumina substrate. The foreign material was identified as potassium contamination from the cascade rinse tank used prior to the wraparound process. Our wraparound construction consists of sputtered TiW and gold, followed by electroplated Ni and SN60 solder (Figure 2).

The voids are not visible prior to soldering, but a post assembly visual inspection will reveal the defects. A screening process has been developed using hot solder dip and 100% visual examination to remove devices that have the propensity for voiding. As of January 17th 2011 all shipments of thin film MIL-PRF-55342 solderable devices have been screened to mitigate the shipment of potentially defective devices.

A revised pre-wraparound cleaning and inspection procedure was implemented on January 28th 2011, and the results indicate that the end band voiding has been eliminated. To date 57,611 pieces of the revised cleaning procedure have been assessed with no defectives found. We will continue to sample a significant portion of current production to assure end band termination quality. In addition, we are pursuing alternative construction for the wrap around process to simplify the process, make visual examination of the base layer metalization stack possible, and provide a more robust product.
