State of the Art, Inc.

Thin film MIL-PRF-55342 termination material B (solderable) metal voids

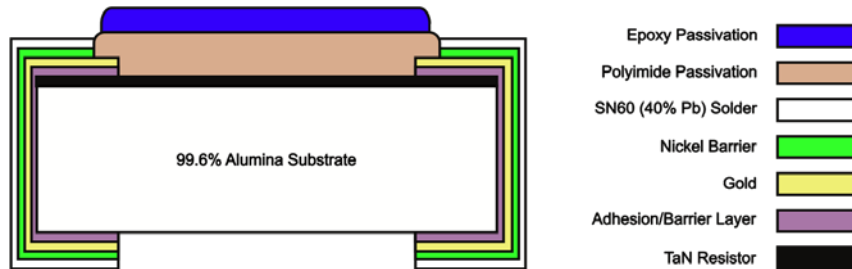
Figure 2. Schematic cross section of a thin film, solderable, MIL-PRF-55342 resistor.

The investigation of the affected lots indicates that the cause of the termination failure is due to voids in the end face metal. The cause of the voids is foreign material contamination preventing the adhesion of the sputtered TiW material to the alumina substrate. The foreign material was identified as potassium contamination from the cascade rinse tank used prior to the wraparound process. Our wraparound construction consists of sputtered TiW and gold, followed by electroplated Ni and SN60 solder (Figure 2).
